SOIL DYNAMICS AND THE EARTHQUAKE DESTRUCTION OF THE EARTHEN ARCHITECTURE OF THE ARG-E BAM

*Randolph Langenbach**

ABSTRACT: *The Arg-e Bam is a remarkable example of earthen architecture and construction that was heavily damaged in the Bam earthquake of 26 December 2003. This paper presents findings that the collapse of the walls was from a combination of the effects of (1) the additive changes made to the walls, particularly in recent restorations, and (2) extensive damage from termites and loss of the cohesion of the clay, all of which interacted with the unusually high frequency of the earthquake vibrations in such a way that many walls simply burst from the subsidence of their clay internal cores. Concern is raised for similar risks to other earthen monumental structures from future earthquakes.*

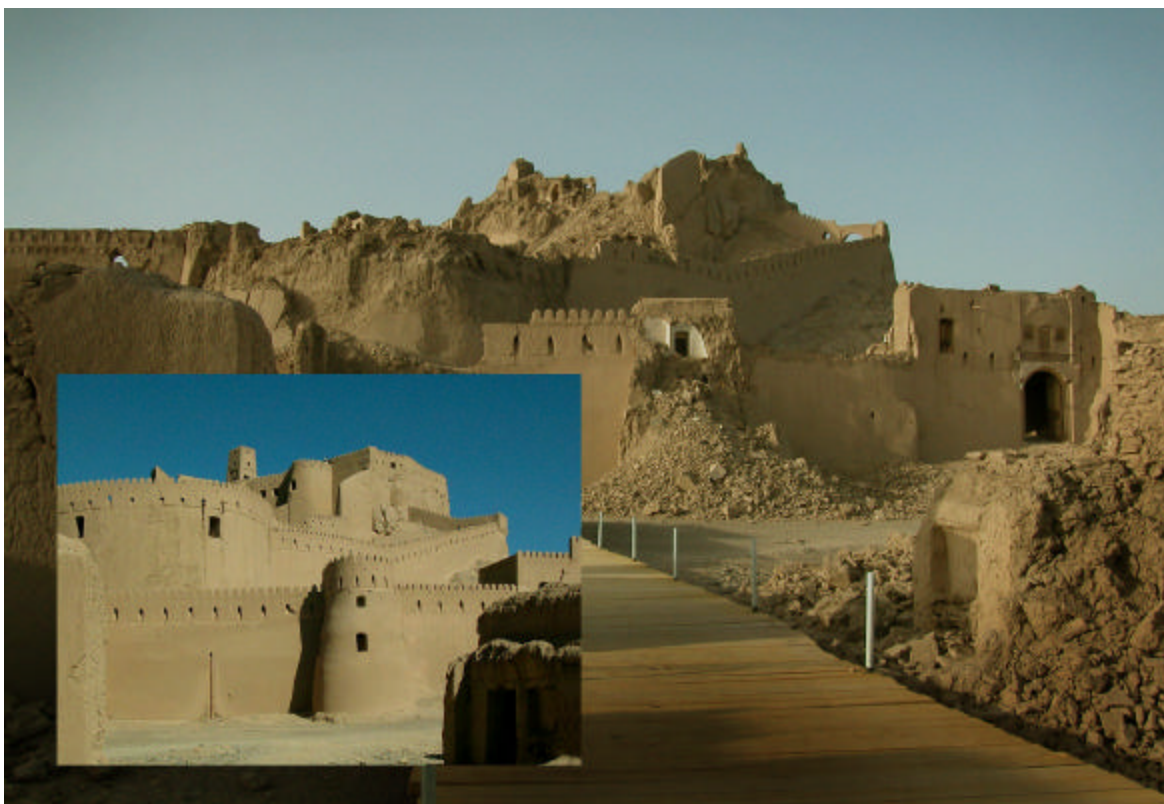
Figure 1: The Arg-e Bam upper citadel before and after the earthquake. *Before photo by James Conlon, 2003.*

In the case of (2) the collapse of the structures at the top of the hill (Figure 1), this seemed to be caused in part because the failure of the retaining walls and fill that had been constructed up from the lower hillside to

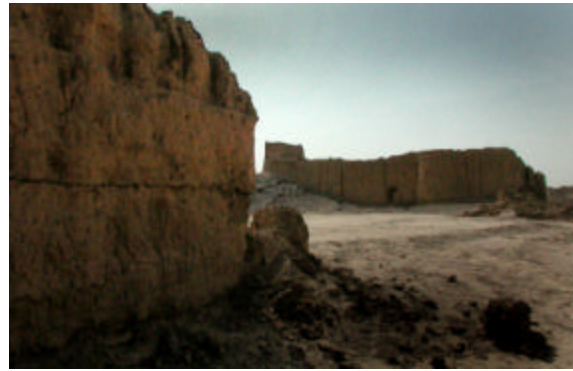
Figure 3: Unrestored ancient earthen structures just outside of the Arg walls to the north after the earthquake. These structures were only lightly damaged.

with significantly less damage than did those that had been restored and even strengthened in recent years. (Figure 3)

The unmodified and restored structures included most of those in the north-west section of the walled town known as the “Konari” neighborhood, and also those structures just outside of the Arg to the north-east including the tall “Shahrbast Wall,” located near the icehouse, and the “Khale Dokhtar,” located on the opposite riverbank. Some of these surviving unrestored structures are of considerable size and height, and were undoubtedly subjected to shaking of close to the same characteristics as the rest of the Arg, but they remained standing, except for some smaller parts that broke off. (Even in these few collapsed sections in the Khale Dokhtar and other structures, termites were also in evidence.) (Figures 3, 11, 20 & 27)

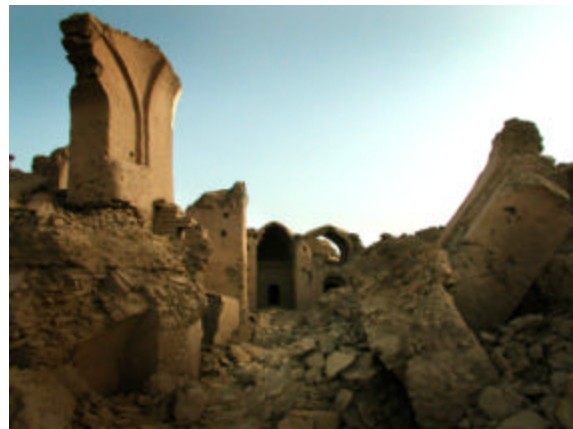
Figure 4: View of the ruins of the Arg-e Bam.

At first view, the damage to the Arg is so extensive as to defy one to classify or interpret it. The structures were pulverized, often leaving only mounds of rubble at the base of a few remaining standing walls and piers.

Despite its history as a fortified site, all of the walls and buildings in the Arg were composed of unfired earth, and thus were weak and brittle. Yet even if one recognizes this fact, the extent of the destruction was nevertheless remarkable. There have been few past earthquakes to prepare one for the extent of the destruction seen both in the Arg and in the modern town adjacent to it. There was hardly a single building type, ancient or modern, that did not suffer total destruction. Even many of the steel frame buildings constructed over the last decade ended up with their steel frames wrapped into shapes like pretzels on top of heaps of crumpled infill masonry walls and floors. In the case of the ancient Arg, little remained that resembled complete buildings. A sea of formless rubble extended out as far as the eye could see. Even the Governor's House and Tower astride the hill that formed the central symbolic image for the site disappeared, leaving behind ruins that resembled a natural rock outcropping, untouched by human hands (Figures 1&4).

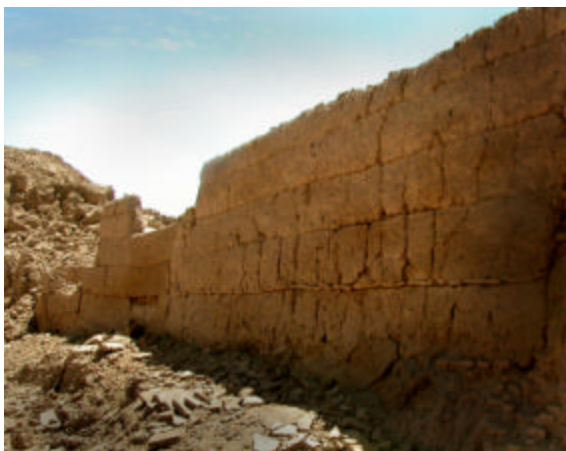
Figure 5: *Chineh* wall inside the Arg-e Bam that was only slightly damaged in the earthquake.

The Arg-e Bam has been recognized as the world’s largest earthen complex. Unlike many earthen monuments that are clad with brick or stone, the structures in the Arg were entirely composed of unfired earthen construction. This construction was of two distinct types – unfired “adobe” masonry, known in Farsi as “*Khesht*,” and built up earth or “cob” construction, known as “*chineh*.”³ (Figure 5)

Many *chineh* walls, both ancient and modern, proved to be remarkably durable in the earthquake. As one approaches the Arg, passing through areas of gradually increasing damage, these walls are seen to have remained standing even when whole houses and multi-story steel frame buildings nearby were collapsed. Near the Arg, the damage to the garden walls is clearly greater, but large sections of them have nonetheless remained standing that were both parallel and perpendicular to the direction of the earthquake waves. In the Arg itself, a number of the antique *chineh* walls not a part of buildings survived with little damage, as buildings collapsed around them (Figure 5).

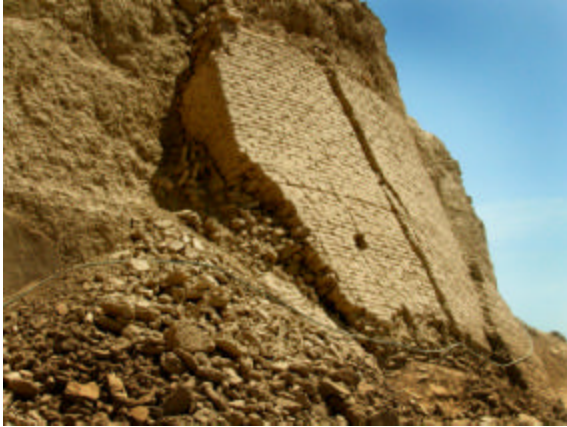
Figure 7: View of collapsed outer walls of a round tower. The *Khesht* construction of the outer layer has fallen off of the earlier inner layers that are most likely a combination of periods of building in different methods.

Even the arches, vaults and domes were constructed of sun-dried bricks using a technique of construction that avoided the need to provide structural centering. Both types of construction could be found in many of the structures, sometimes in layers where the later work, including 20th century restoration work, would be in *Khesht*, while the original work would be *chineh* (Figures 7 & 15).

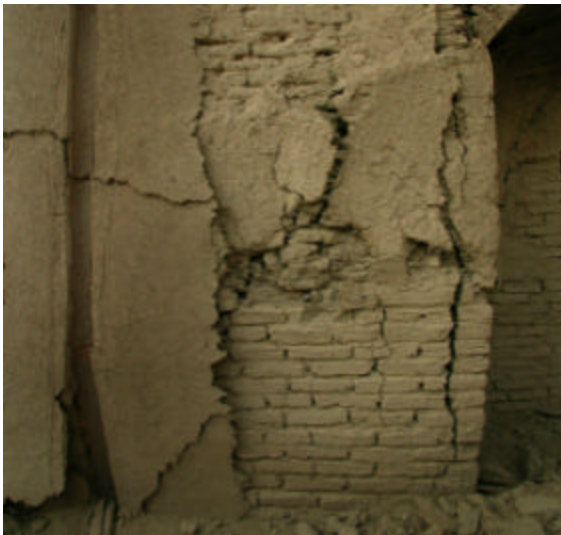
Figure 8: Pier in a partially collapsed section of the Caravansary showing the bursting of the outer layers from internal expansion from the earthquake vibrations.

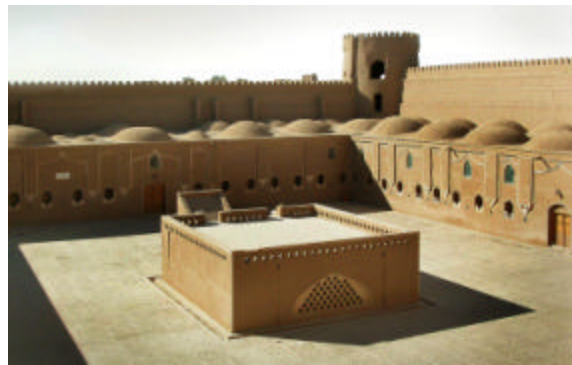
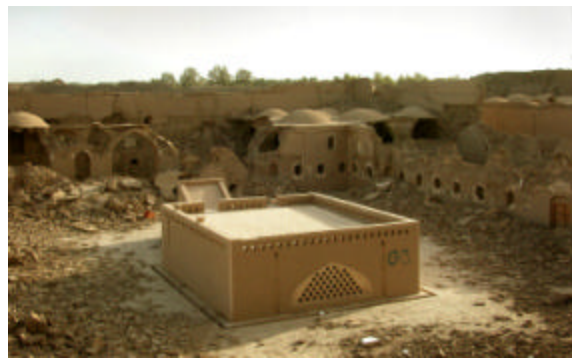
Figure 9&10: Before (November 2003) and After (April 2004) of the same view of the Stables courtyard showing the superstructure over the cistern that was recently reconstructed in fired bricks.

For interesting survivals, one could not help but notice (5) a fired brick reconstruction of a structure with internal vaults over an ancient water cistern in the center of the stables courtyard (figures 9 & 10). In a rapid survey of this one-story building, there was no evidence of even so much as a crack from the

earthquake. In aerial photographs taken in 1974, the cistern was uncovered and the current structure is a recent reconstruction in modern fired brick masonry. (6) The outer ramparts on the south, east and west sides of the walled city suffered a great deal of damage, with the loss of their projecting turrets and complete destruction of the top crenellations and walkway, yet the north facing ramparts survived in better condition (figure 18). (7) In the structure known as the “Caravansary,” the second level of the side that had a series of buttresses along the outside wall collapsed, whereas the opposite side, which had no buttresses, survived almost intact (Figure 19).

By contrast to the bursting walls (5), the masonry structure over the cistern in the center of the stables courtyard performed so much better despite being of unreinforced masonry. Most likely in this case, the walls were of a uniformly solid and bonded masonry construction without a rubble core. The fact that it was constructed of fired brick would have contributed to its strength, but what may even have been more important was the fact that the walls were of a fully cohesive material of uniform density without voids or vertical gaps. As for the better behavior of the north-facing ramparts compared to the other city walls (6), the subsurface soil conditions along the river bank may account for some of this difference by damping out some of the vibrations. In addition, like the nearby Konari neighborhood, these walls had not been altered and restored along their tops as much as had the other walls around the Arg. It was the newer restored upper level battlements, walkways and crenellations that consistently suffered the most.

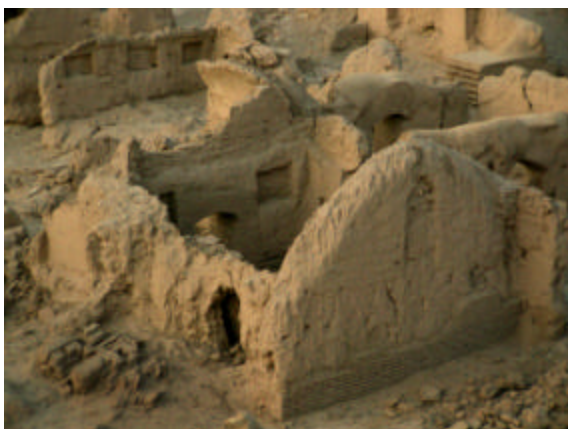
Figure 11: Unrestored ruins in the Konari neighborhood of the Arg-e Bam that survived the earthquake with comparatively little damage.

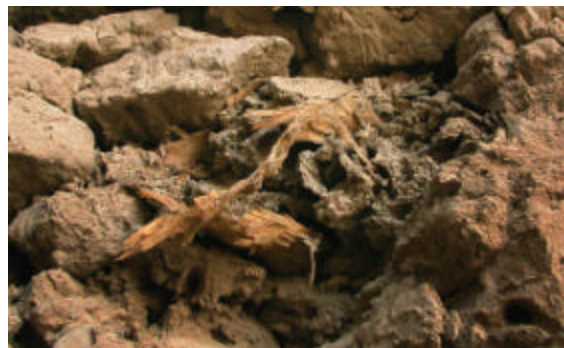
Figure 12: View of section of earthquake-caused collapse showing timber consumed by termites.

No longer did many of these walls consist of horizontal layers of earth or sun-dried bricks. Those that did consistently appeared to be less damaged. Instead, through generations of erosion, repair and remodeling, many of the walls had evolved into a series of vertical layers of earth, standing together like books on a shelf without bookends. Each of the different layers was of a different density and cohesion resulting from the different ages, construction characteristics, and degradation. For example, modern *Khesht* (adobe masonry) frequently encased older *chineh* (cob) construction (Figure 15), and the organic material used for reinforcement had rotted or been consumed by insects, leaving cavities and friable earth (Figure 12).

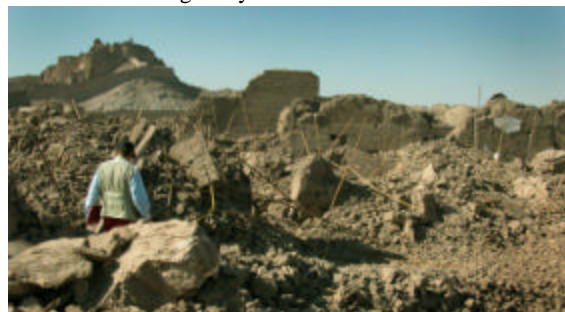
Figure 13: Ruins of the Grand Mosque. The north-west section of the main courtyard was on the right side of the view.

In the Arg, even the usually common diagonal or “X” cracks were relatively rare. It appeared as if each structure exploded from the inside and crumbled straight to the ground in a scatter of small pieces. Rubble was everywhere, forming a mat of broken material that in some places was almost as high as the still-standing remains of the walls. The Grand Mosque was, for example, completely unrecognizable after the earthquake. In the rubble pile, there was even barely enough left intact to discern the outline of what had been its large courtyard (Figure 13).

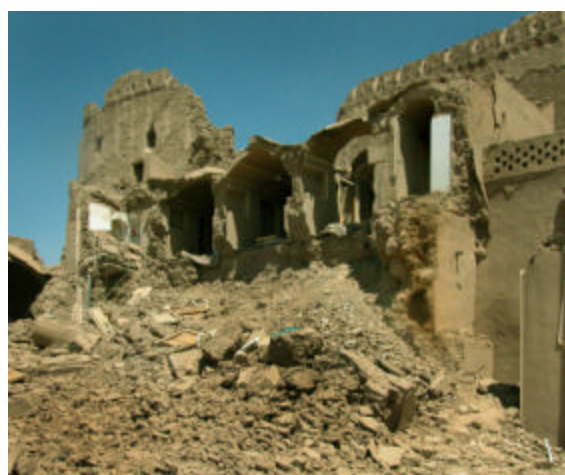
Figure 14: Buildings above the Stables courtyard that collapsed from the lateral spreading failure of the retaining wall and fill beneath.

The more we examined the site, the more compelling this explanation became. In a number of locations there was evidence of lateral spreading of the kind that one would expect to find around the shore of a lake – but in this case it was located on dry ground where historically the surface had been built up to create the level terraces on which the buildings were constructed on the lower hillside. One section of the terrace that supported a building above the stables collapsed altogether, carrying away the front half of the rooms constructed on it (Figure 14). The round turrets appeared to have failed at the bottom instead of splitting apart at the top, as one might have expected. Their seemingly strong walls were simply pushed out at the base, with sections of the upper walls having slid down the rubble with the upper ornamentation remaining as the only recognizable pieces left.

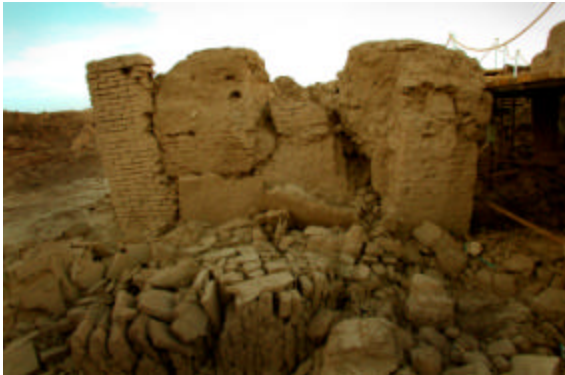
Figure 15: A massive pier composed of different periods and types of *Khesht* and *chineh* construction that have separated from each other during the earthquake.

widen the platform at the top of what had originally been a narrow rock outcropping. The failure of (3) the walls of many of the buildings and ramparts was also consistent with the lateral spreading of the material in the cores of their walls, with the exterior adobe bricks being forced out as manifested by the greater frequency of vertical cracks as compared to diagonal cracks (Figure 15 & 17).

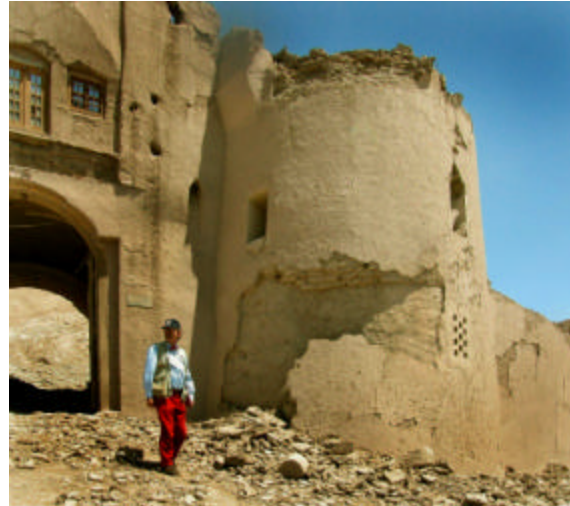
Figure 16: One of the few surviving turrets has evidence of timber reinforcement that extends through the walls, probably from a timber floor structure at the level just below the windows.

For example, in the case of (1) the first observation, the particular vulnerability of the circular turrets can be explained by the fact that they had contained large amounts of unconsolidated fill in their bases. One of the few that survived is to the right of the 2nd gate (Figure 16), and it has evidence of timber reinforcement – probably holding a floor – that may have been instrumental in holding it together.

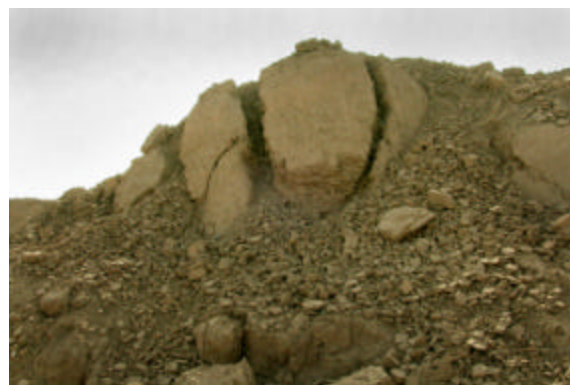
Figure 17: Collapsed round turret on the ramparts that shows evidence of having burst apart from collapse of internal layers.

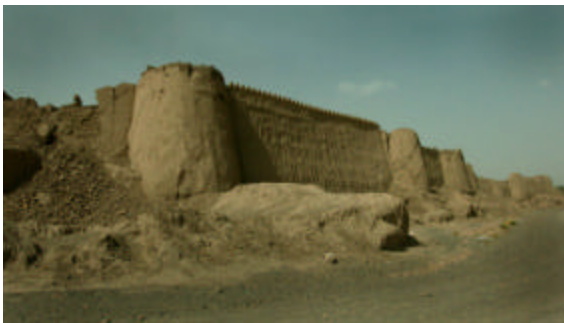
Figure 18: North-facing ramparts that were significantly less damaged in the earthquake than the other city walls. Notice that the crenellations are still intact on this one section, the only section where that was observed to be the case.

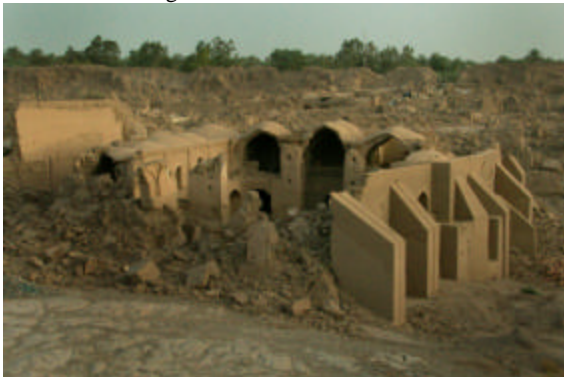
Figure 19: The ruins of the Caravansary show that the domed rooms on the second level behind the buttresses have collapsed, while the ones opposite still remain. There are no buttresses behind the external wall of the opposite side. The base of one buttress is crushed.

The second-to-last item (7) is the Caravansary where the rooms on the second level of the buttressed west side of the complex collapsed, leaving the east side that lacked buttresses largely intact. The buttresses themselves were also damaged, with one collapsing from the crushing of its base.

The story of this complex became even more interesting when I learned that the side that collapsed had been almost completely reconstructed only a few years earlier, whereas the still standing side had mostly survived from antiquity. In aerial photographs of the caravansary taken in 1974,⁷ the domes on the east side were almost completely intact, whereas on the west side they had collapsed. At that time, the buttresses on the west side only extended up to the level of the first floor. As late as 1996 the condition of both sides was similar to 1974, except that the small holes in the east side had been fully repaired.⁸

At the time of the earthquake, photographs show that the restoration of the west side of the Caravansary had been completed.⁹ The domes had been reconstructed and the west wall and buttresses had been extended up to the roof level. Ironically, in the earthquake, it was this mostly newly constructed and fully buttressed side that fell. This was simply one more example of (8), the fact that many where the areas of the greatest amount of strengthening, reconstruction, or even of continued maintenance (as was the case with the upper citadel) were the most heavily damaged.

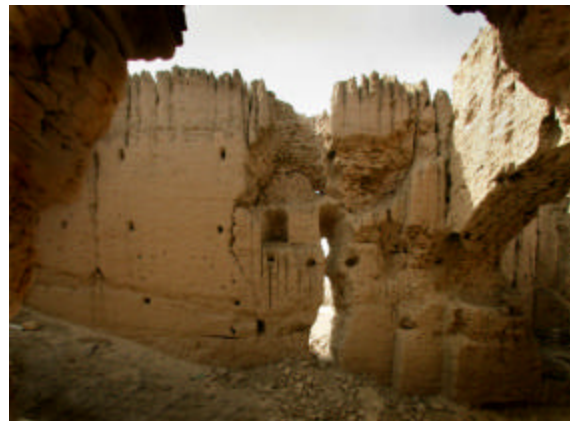
Figure 20: The interior of the unrestored structure in Figure 3 showing 3story high walls that survived the earthquake. Notice the older section with later work constructed around it. This is a good example of the onset of damage at the interface of construction of different age and type, as a small area of collapse has revealed this interface. Notice the debris on the ground.

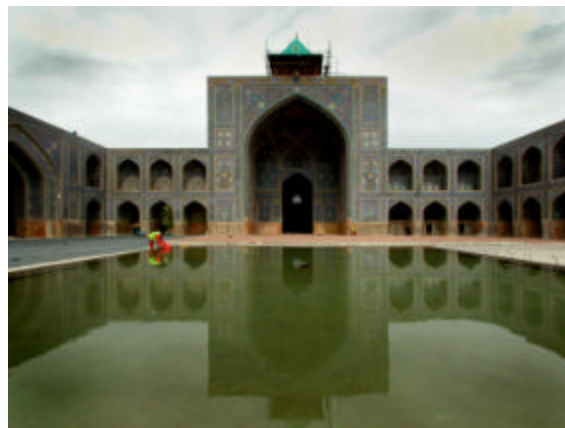
Figure 21: The Imam Mosque in Isfahan, April, 2004. The inner cores of many of these walls and the walls of other great monuments in Isfahan are constructed of unfired clay.

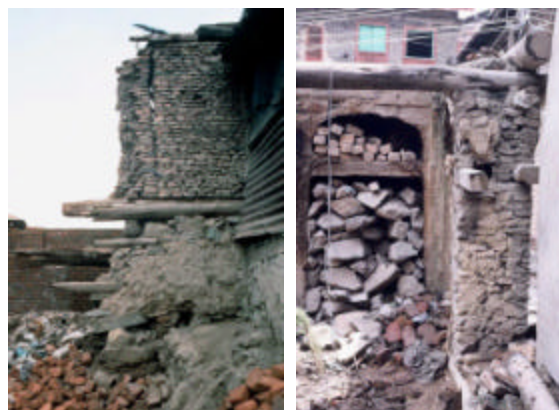
Figure 22: Two views of a multi-story dwelling under demolition in Srinagar, Kashmir showing the timber lacing laid horizontally into walls of masonry with mud mortar.

Part of the Palace and some other massive old buildings collapsed ... [but] it was remarkable how few houses fell.... The general construction in the city of Srinagar is suitable for an earthquake country; wood is freely used, and well jointed; clay is employed instead of mortar, and gives a somewhat elastic bonding to the bricks, which are often arranged in thick square pillars, with thinner filling in. If well built in this style the whole house, even if three or four stories high, sways together, whereas more heavy rigid buildings would split and fall.¹³

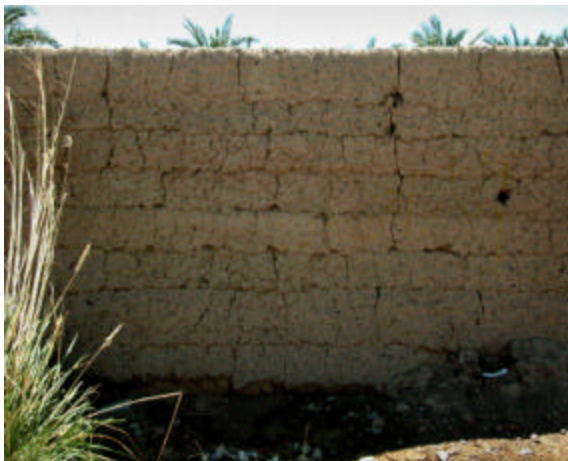
Figure 23: *Chineh* garden wall, probably of recent origin, in Baravat (near to Bam). This wall shows the cracks that commonly exist in *chineh* walls, and how the layered construction helps to ensure stability by allowing the cracked sections of the mud layers to perform like large blocks of masonry.

To begin to understand what can be done with traditional earthen construction, it is helpful to look not only at what fell, but what did not. For this we turn to the *chineh* garden walls around the date palm orchards throughout the city. The *Chineh* garden walls are generally about two to two-and-a-half meters high and 50cm thick at the base with a batter reducing them to only a few cm thick at the top. Most of the date palm groves in Bam and in Barakat are surrounded by walls of this type. The Iranian *chineh* construction found in Bam is characterized by a series of bands of clay that are about 50cm high that represent each “lift” in the construction process. These lifts were constructed along the wall from one end to the other, and then made smooth and level on the top before proceeding with the next lift. (Figures 3, 5, 23 & 24)

This differs from Northern European cob construction, which lacked such clearly defined horizontal interfaces between the lifts. There may have been a number of reasons for this construction detail in *chineh*, such as water shedding, but one structural reason for it may have been that it served to stop the continuous propagation of vertical cracks through the wall, a problem that is all the more acute in a dry climate. Because they are constructed only of uncompressed dried mud, they began their life with many vertical cracks and checks from the initial drying out process. In fact, the Getty Seismic Adobe Project report states: “Substantial cracks nearly always exist in historic adobe buildings as a result of past earthquake activity, wall slumping, or foundation settlement. Cracked walls are a typical feature of these buildings”¹⁵

Throughout history, Iranian builders would have striven to avoid the negative structural effects of this inevitable cracking as much as possible. The horizontal control joints in the *chineh* walls may be a result of this effort by interrupting the progression of cracks through what would otherwise have been a uniform material.

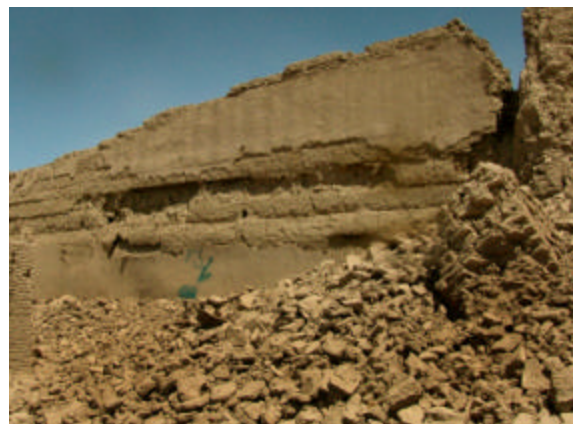
Figure 24: South-facing outside wall of the stables courtyard showing how the layering of the *chineh* walls has interrupted the cracking and collapse of sections of the wall, thus helping to maintain the stability of the partly undermined upper part of the wall.

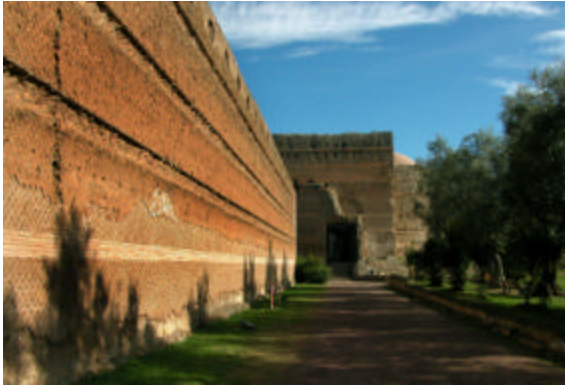
Figure 25: Long Wall, Hadrian's Villa near Rome showing the bands of brick that were laid into a wall constructed with natural cement with a tile facing. The crevices are the result of the later chipping out of the bricks for re-use.

pozzolanic cement. These great lumps of material have shown a remarkable durability, but one feature in many of these walls stands out. Every meter and a half or so was a horizontal band of fired brick masonry that extended through the walls. The early Roman bricks were essentially a flat thin tile. The original purpose of these bands is not known from any literature source, and archeologists often differ in their interpretations, but it is clear that they did serve as “crack stoppers.” By interrupting the uniform matrix of the natural cement with the bedded layer of bricks in mortar, inevitable cracks that occurred in the cement layer were interrupted, giving added stability to the wall.

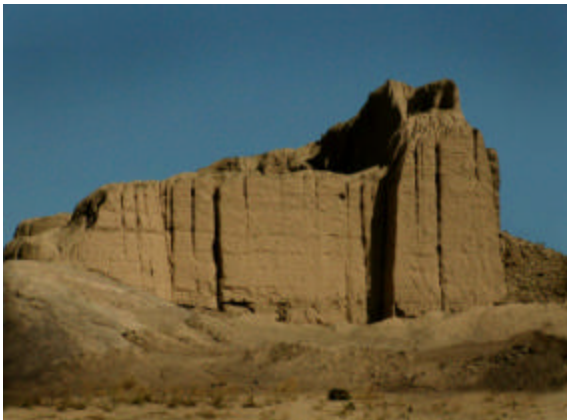
Figure 27: The unrestored Khale Dokhtar, a small Arg (or citadel) on the riverbank opposite the Arg-e Bam that survived the earthquake with the collapse of some arches. The high walls of the massive structure otherwise survived intact. (Termites and other insects were also in evidence where the collapses occurred.)
